Title: An Evaluation of the ASM2000 software

Author(s): Mclean, Thomas Donaldson
Gildea, Timothy R.

Issued: 2021-07-12

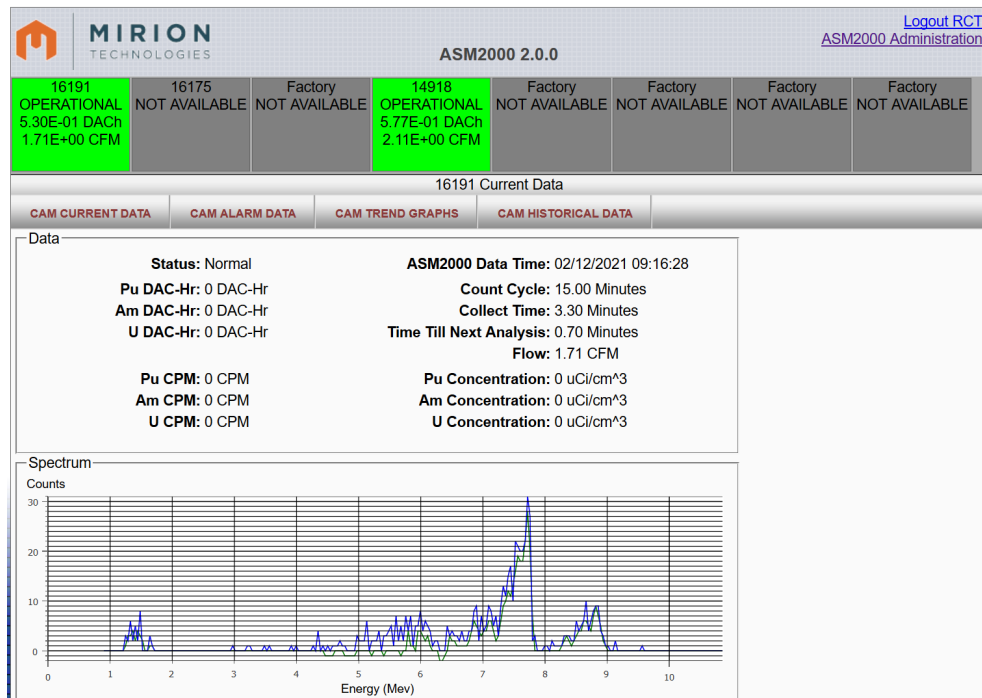
Figure 4. ASM2000 main display page. Two CAM heads at positions 1 and 4 are connected to the Tablet

However, inconsistent behavior was often noted in acknowledging the radiation alarms. Silencing the horn from the browser (Fig. 4) was almost always successful with a single acknowledgement (though sometimes two were needed) and initiating a subsequent filter change always cleared the CAM strobe light. But the status box for the affected CAM often continued to display the Alarm message long after the filter change and even into the next count cycle even though there was no trace of TRU activity in the CAM spectra (the source was removed during the filter change). Sometimes the Alarm message eventually cleared on its own but often, it was only cleared through repeated alarm acknowledgements. In at least one instance it was necessary to power cycle the CAM head to clear the alarm message. It was also observed that in these acknowledge-

Most fault conditions (e.g. low flow rate or door open) could be readily addressed using the Alarm acknowledgement button on the Administrative Actions page (Fig.4). Usually only one acknowledgement was required but sometimes two or more were necessary. For more serious faults (e.g. Instrument Fault), a reboot of the software was often required which affected all the CAMs by taking them out of service while the reboot was in progress (~ 2 minutes).

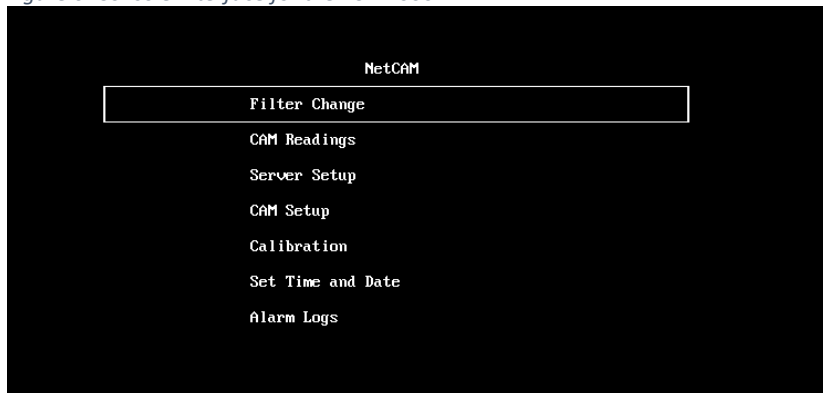
Figure 6. Console Interface for the ASM2000

A DOS-like console interface program (Fig. 6) is co-loaded with the ASM2000 software and runs in the background. Many of the ASM2000 configuration parameters can also be setup using the console interface. This interface also has additional information not available within the ASM2000 application. For example, the dates at which the last flow rate and efficiency calibrations were done.
